## Water Compliance Inspection Report

***National Pollutant Discharge Elimination System  
(NPDES) Inspection Report***

***Anderson Farm Property  
Ferndale, WA***

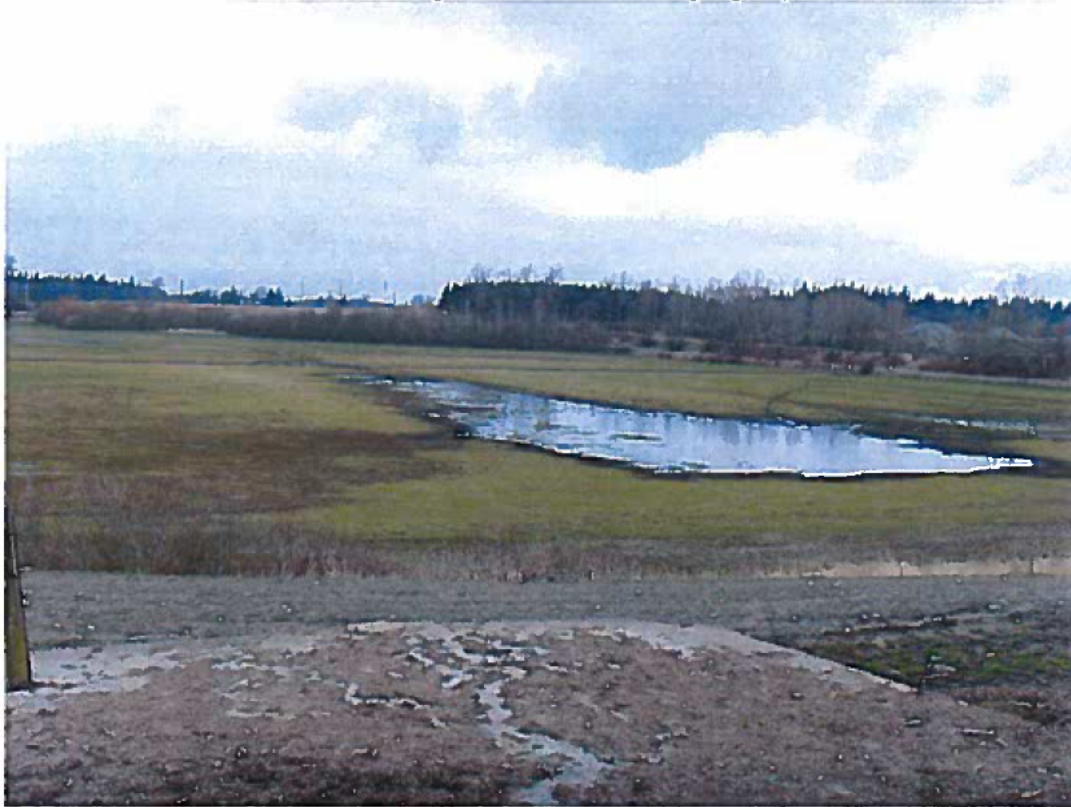
Photo #1: Facing west, view of a pasture/field on the property.

The Anderson Farm Property has been leased to Mr. Katz for about 20 years. According to Mr. Katz his operation is a hobby farm raising beef cattle and is not a licensed business. Mr. Katz stated that he owns about 200 cows which are pastured at the property during summer months, usually from April until October. During the winter months the animals reside in eastern Washington. At the time of the inspection there were approximately 15 cows on the property, mainly bulls that are kept separate from the herd. See Attachment B, Photo #1 - #2.

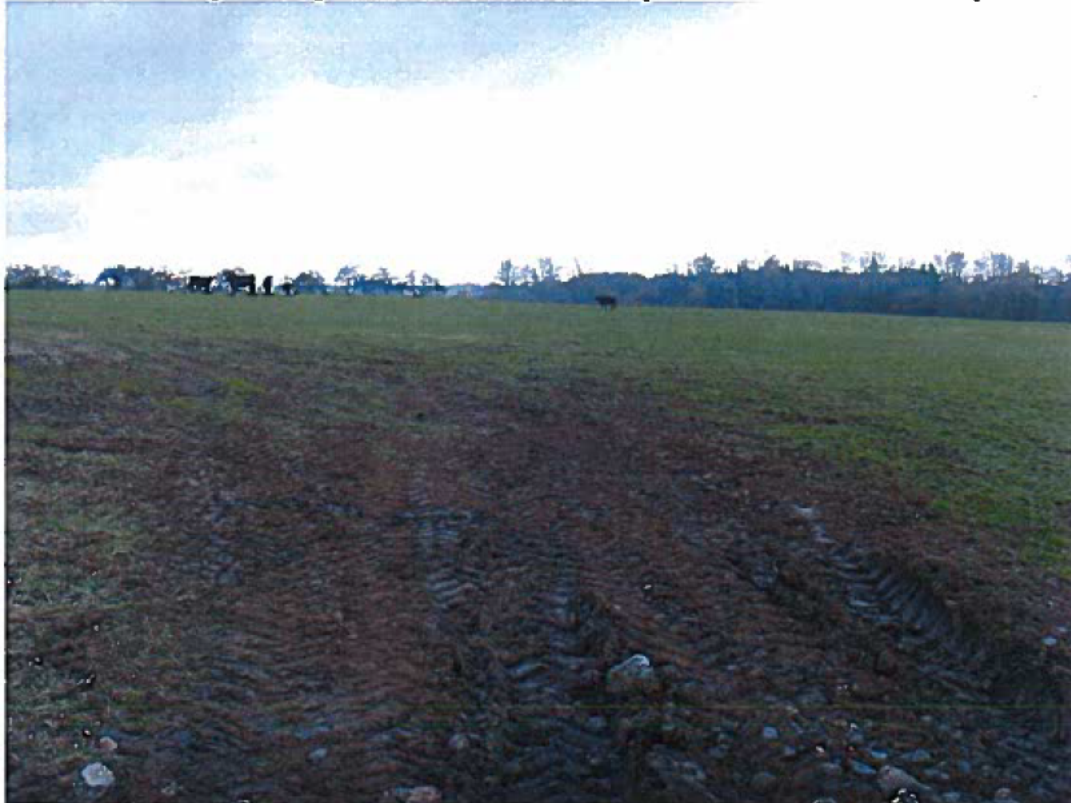
Photo #2: Facing north, photo of the few animals pastured at the time of inspection.

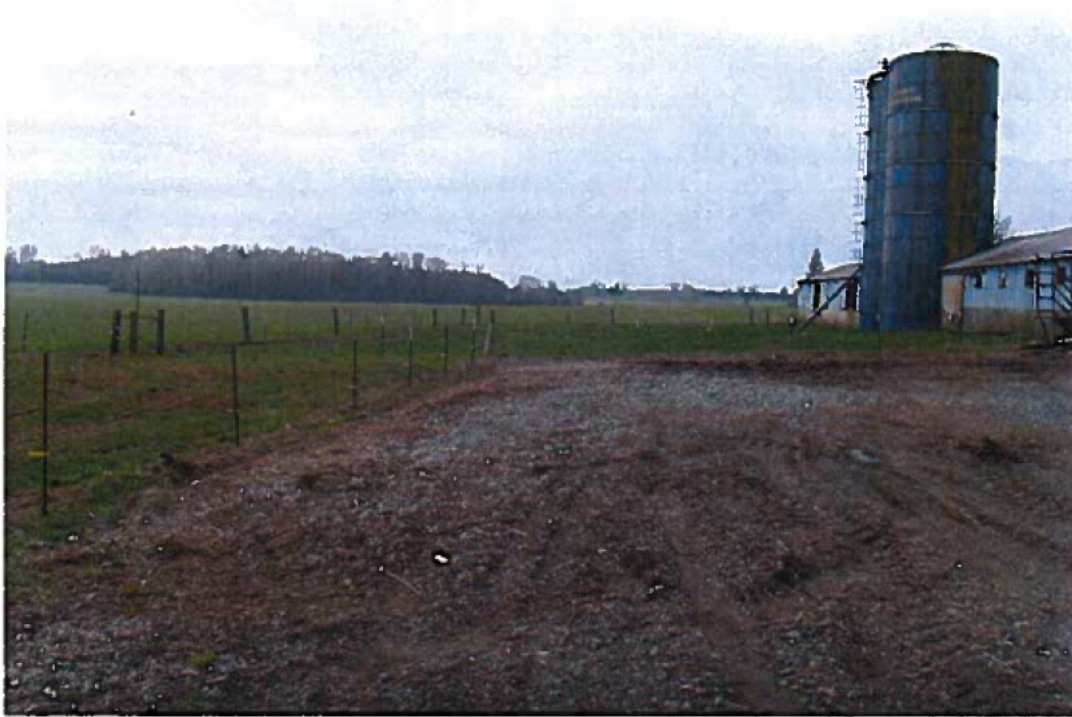
Photo #3: Facing south, view of barn area and pasture.

According to Mr. Katz the animals are never confined. The barn structures at property are used only to gather the heard for loading and transport at the end of the summer. A section of one of the barns is occasionally used for veterinarian visits to assess the herd's health. Mr. Katz stated that a few pastures on the property receive land application of manure periodically. The last application of solid manure occurred the day prior to the inspection by a friend of Mr. Katz. See Attachment B, Photo #3 - #4.

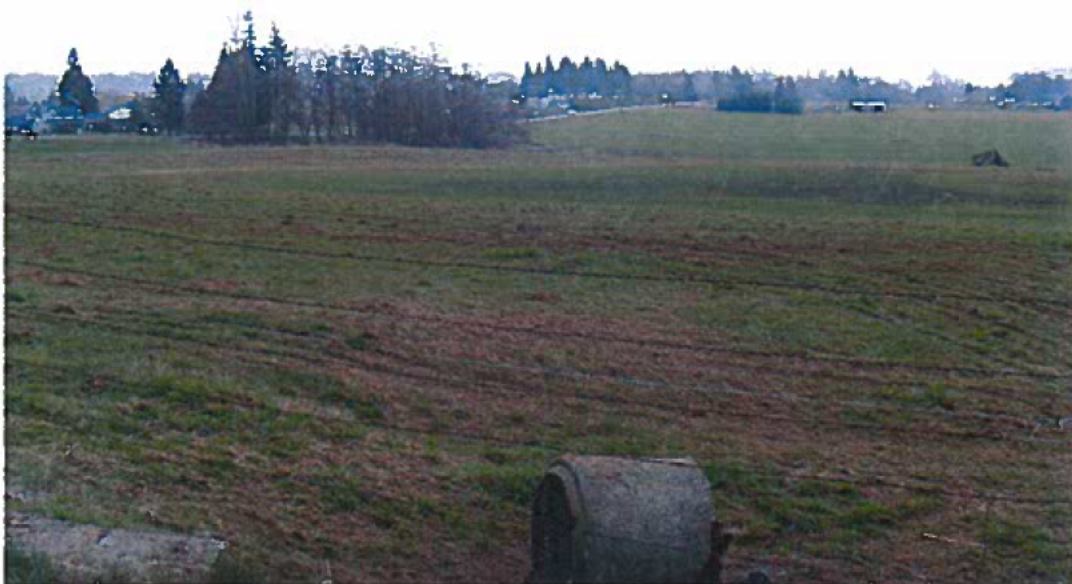
Photo #4: Facing east, view of a pasture/field on the property. According to Mr. Katz, manure solids were applied to the pasture the day prior to the inspection.

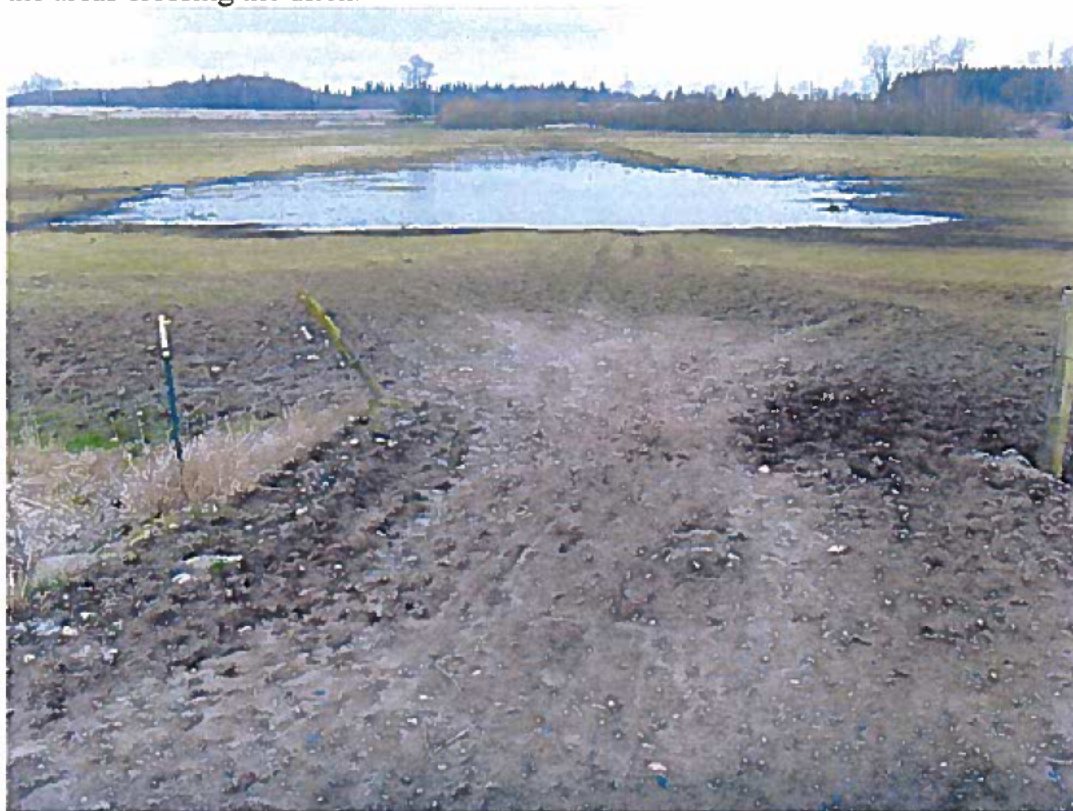
Slope and Proximity to Jordan Creek: During the inspection I observed several areas where animals naturally congregate near the barn structures that were devoid of vegetation. These areas are positioned with a steep gradient upslope of Jordan Creek. It was apparent that during a rain event, stormwater could channel from the devoid/congregated areas in the direction of Jordan Creek. The concern is that due to the slope and proximity to Jordan Creek, when animals are present, manure/animal waste from the devoid/congregated areas could discharge with stormwater to Jordan Creek. There were no berms in place along Jordan Creek. See Attachment B, Photo #5 - #6.

**Photo #5:** Facing west, view of a pathway into a pasture/field. Note that there are no berms along the areas crossing the ditch.

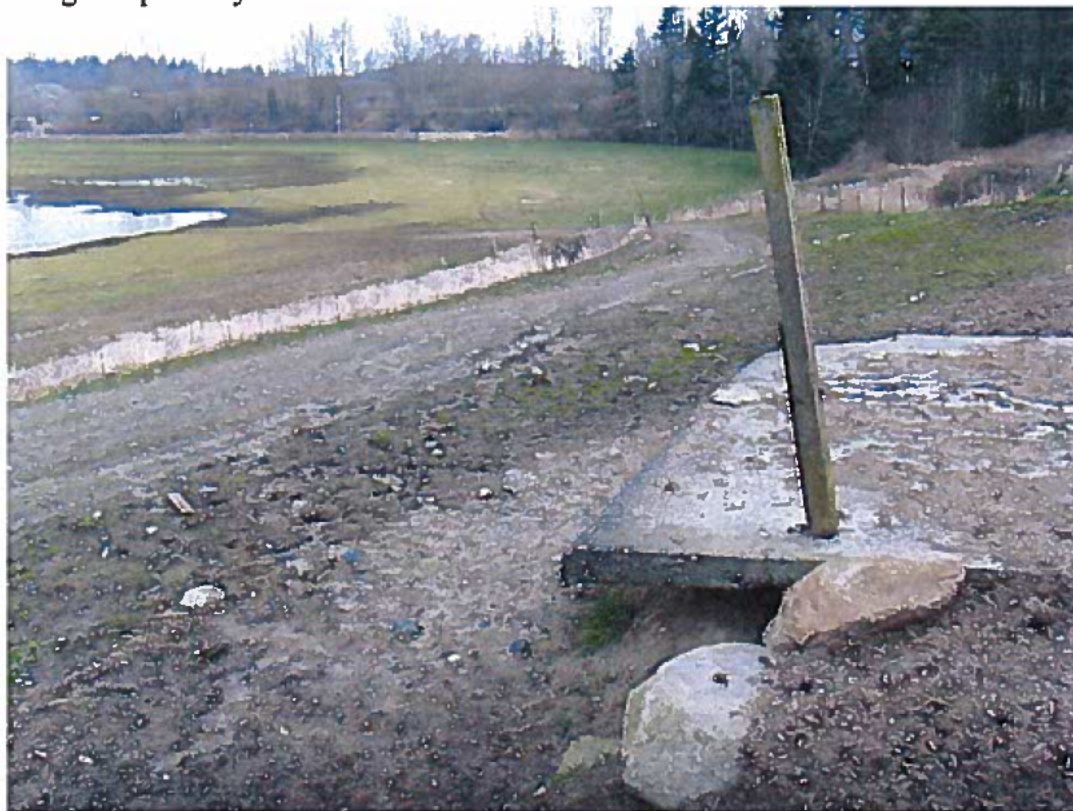
**Photo #6:** Facing north, view of a path leading down to the pasture/field. Erosion was observed along this pathway.
